# Update to the Houston Barnard Streetscape Plan

Prepared for The Garden Lovers Club

J. Galiley Arbor Consulting LLC

October 2020

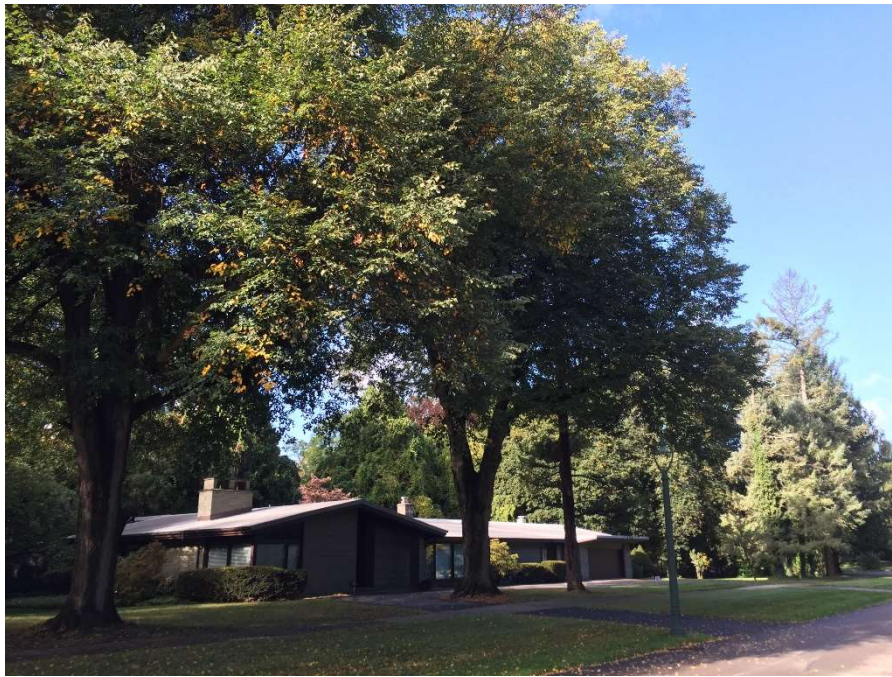
Figure 3. Mature linden and Douglas-fir trees in October of 2020 on Esplanade Drive near Clover Street. Note the missing Douglas-fir to the left of the driveway and the declining Douglas-fir top at the right of the photo.

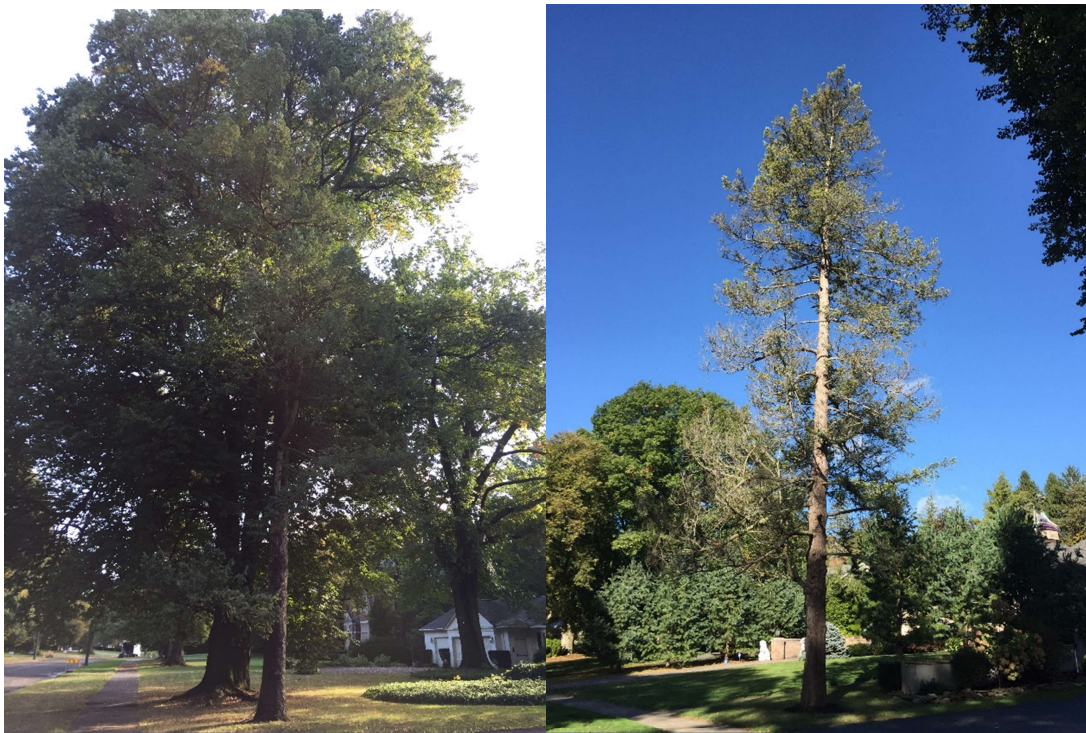
After walking the streets of the Houston-Barnard Subdivision in the spring and summer of 2020, the trends described in 2002 are still in progress. The linden and Douglas-fir plantings remain fragmented. There are fewer Douglas-fir trees. These changes can be seen between 2015 and 2020 in Figures 2 and 3 (above) where one Douglas-fir tree to the left of the driveway has been removed and another shows a dead top and severe decline in the right side of the photo. Other Douglas-firs are being further crowded out as the neighboring linden trees increase their crown size (see Figure 4) or are showing stress and decline as they age (see Figure 5).

Figure 4. A Douglas-fir tree crowded by a linden behind it. Figure 5. A declining Douglas-fir with a thinning canopy.

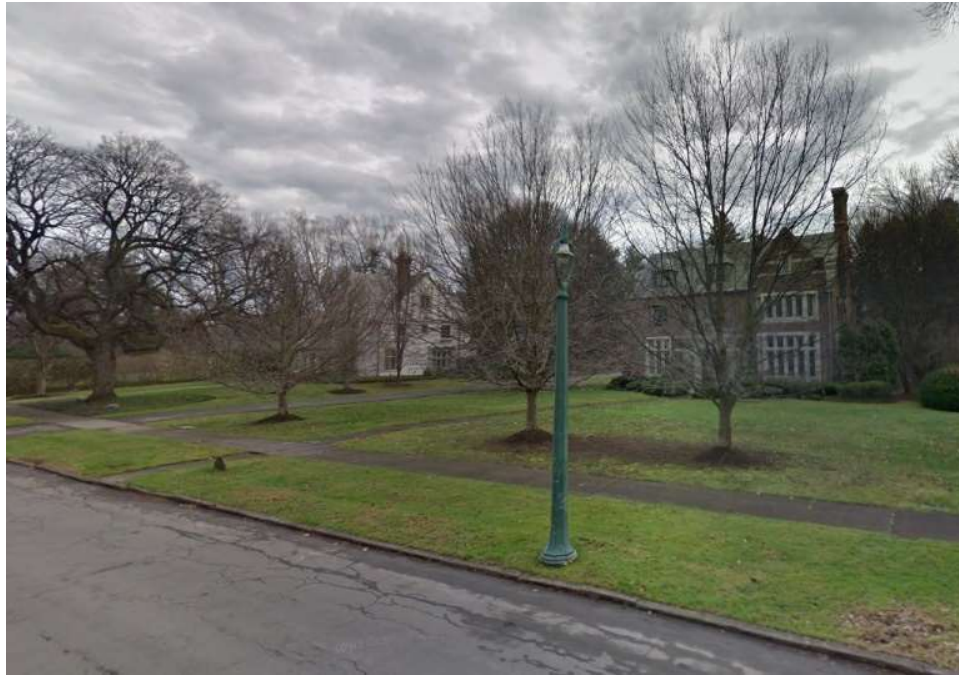
New trees have been planted, but the locations don’t always follow the original streetscape placement or the 2002 placement recommendation (see Figure 6). Many of the lindens that remain have structural issues like cracks and decay (see Figure 7). Some trees have clearly not been inspected in many years as indicated by broken cables and large crotches at risk of failure (see Figure 8).

Figure 6. Red maples planted in place of lindens and closer than 25' apart.

- **Replant trees-** The streetscape can only be maintained by replanting trees as they decline and are removed. Replanting with the original species of linden and Douglas-fir is okay. However, increasing the diversity of species helps prevent the spread of insect infestations and diseases as well as the overall resiliency of the tree population. The following trees are suitable replacements for the linden trees: Crimean linden, silver linden, American basswood, willow oak, scarlet oak, and shingle oak. The following trees are suitable replacements for

the Douglas-fir trees: Carolina hemlock, blue spruce, white fir, and dawn redwood. Trees that have relatively large crowns at maturity (such as oaks and lindens) should be planted approximately 40' apart to provide enough room.

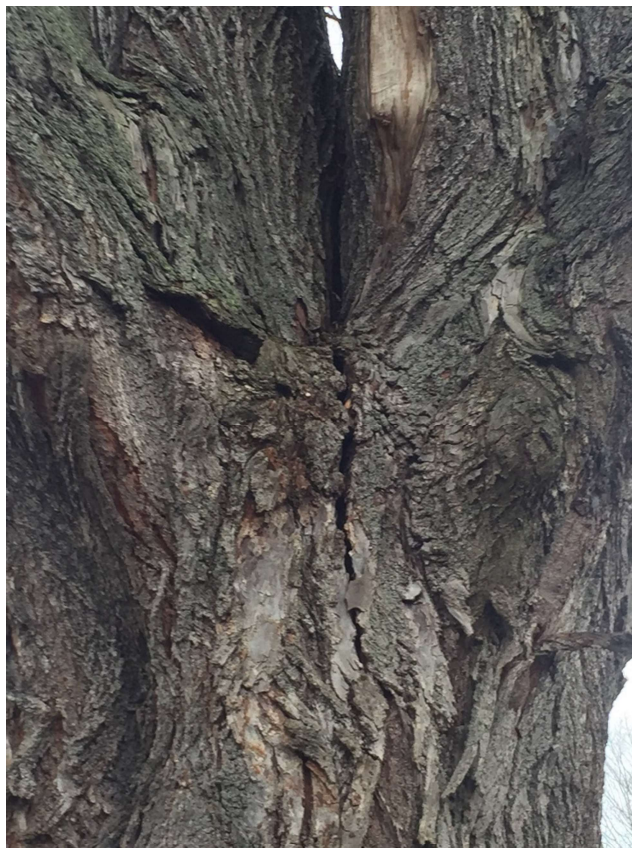
Figure 7. Cracked main crotch of a linden tree.

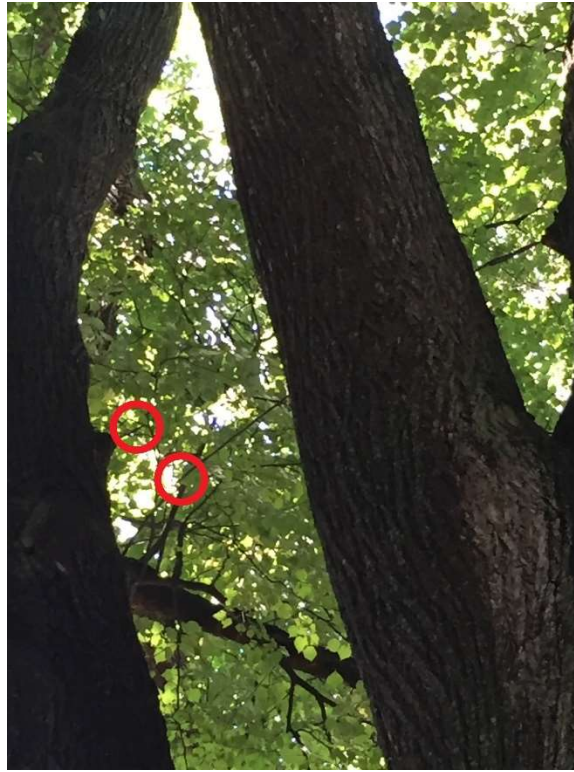
Figure 8. A broken support cable in a linden tree. The two broken ends are circled in red.

- **Periodic health and risk inspection by an ISA Certified Arborist-** Having a tree inspected by an arborist will help manage and maintain its health and structure. Biological and structural problems can be found early and mitigated before they have a major impact on the tree (see Figure 9). Expenses will also be lowered by regular maintenance. A 3 - 5 year inspection cycle generally makes sense for a healthy mature tree. More frequent inspections may be necessary for declining or stressed trees. As Mr. Pleninger stated in his 2002 report, hiring a consulting arborist who is independent of a tree service company to inspect and make recommendations can help ensure objectivity and prevent unnecessary services. Reputable tree care companies and arborists are listed at the end of this report.

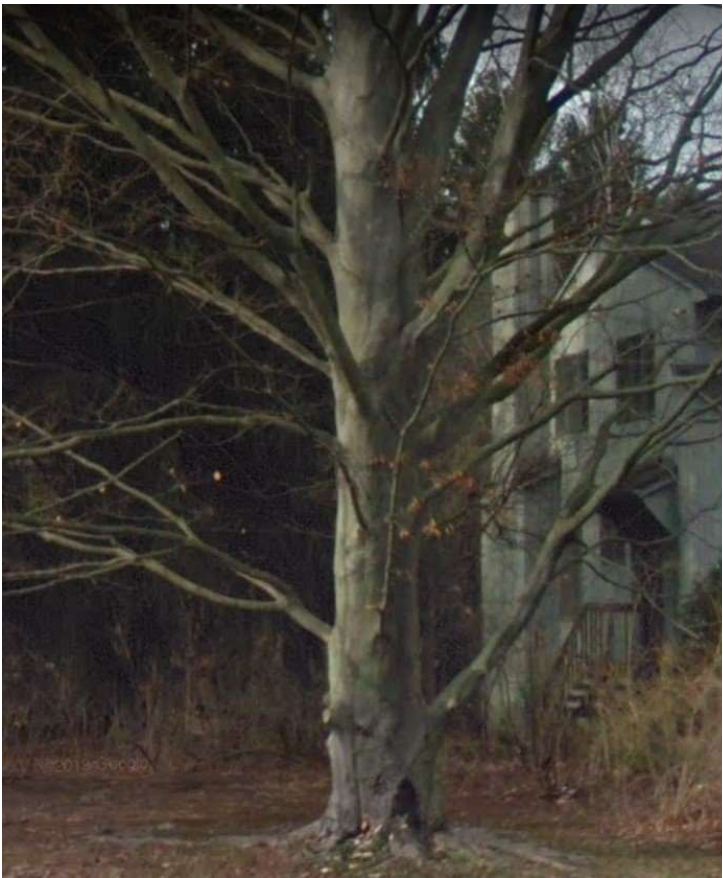
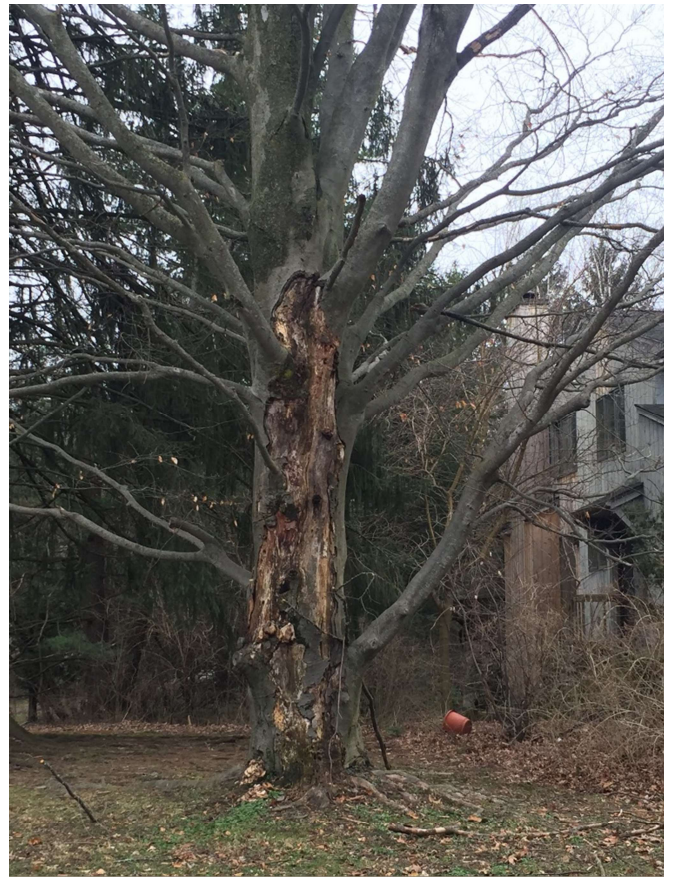
**Figure 9.** A beech tree on Sandringham Road in 2015 (on the left, from Google Street View) and from 2020 with what is likely an untreated phytophthora infection.

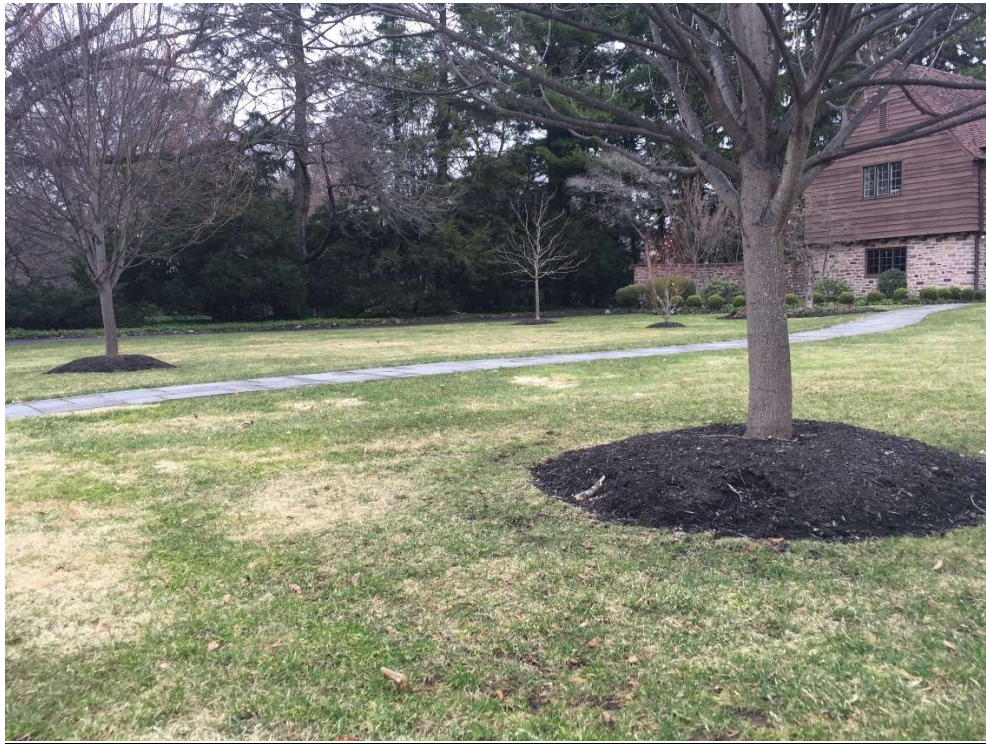
Figure 10. Mulch applied too heavily is burying the trunk flare.

- **Support healthy soil-** Providing healthy soil is the most important part of keeping a tree healthy. In many instances, the soil doesn't need much of anything. Other times, problems like nutrient imbalances and compaction (especially from construction activity in close proximity to a tree) can stress or kill a tree. A soil test is an easy way to see what might be missing from the soil (the Cornell Cooperative Extension offers soil testing services for a modest fee). It will also be a guide as to what type of amendments (e.g. fertilizer or aeration) will be appropriate. Organic mulch is also a fantastic and easy way to help the soil around a tree. As long as the mulch is not piled against the trunk, it can benefit the soil and the roots of the tree.

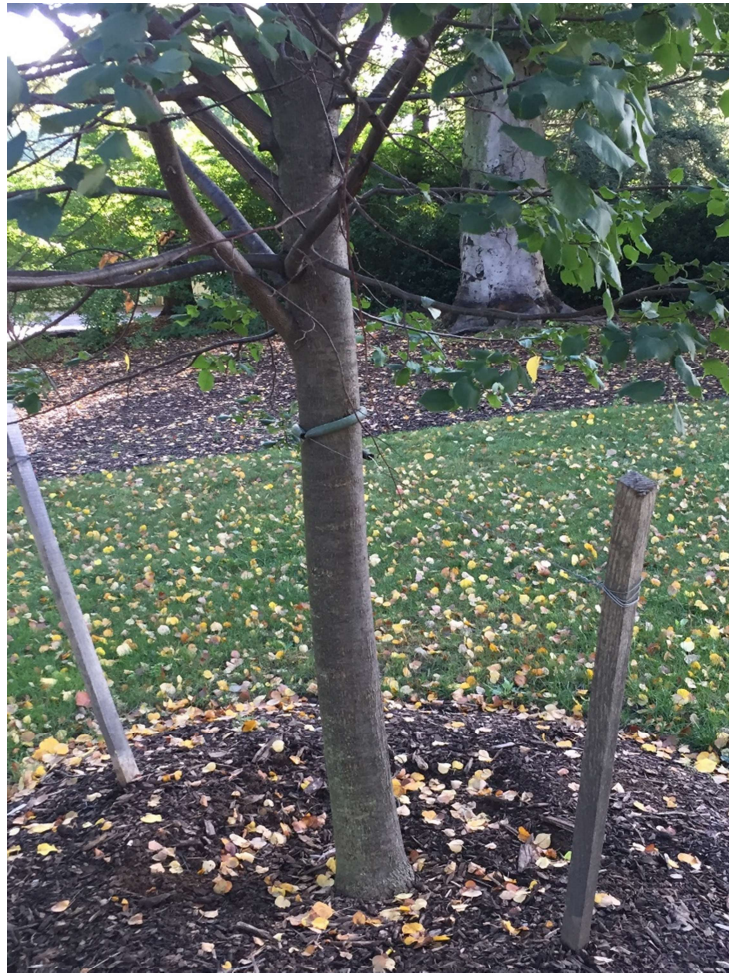
Figure 11. The wires around the trunk of this tree are beginning to girdle it.

- **Ensure the proper planting technique and maintenance of new trees-** Many newly planted trees are given challenges from the day they are planted. Ensure that the tree isn't planted too deep. The trunk flare (where the trunk transitions outward to the roots) should be above the soil grade and should not be buried in mulch (see Figure 10). Roots should not grow in a circle. They should grow radially outward and should not girdle (i.e. cross over) the trunk. Adequate water should be provided for at least the first growing season as newly transplanted trees are often missing close to 90% of their root system. Do not add fertilizer at planting. Wait until the tree is established (one to two growing seasons) and perform a soil test first. Newly planted trees don't always need to be staked. If the tree is supported by stakes and wires, ensure the wires are removed from the tree with in one to two years (long before the wires begin to girdle the tree) (see Figure 11).

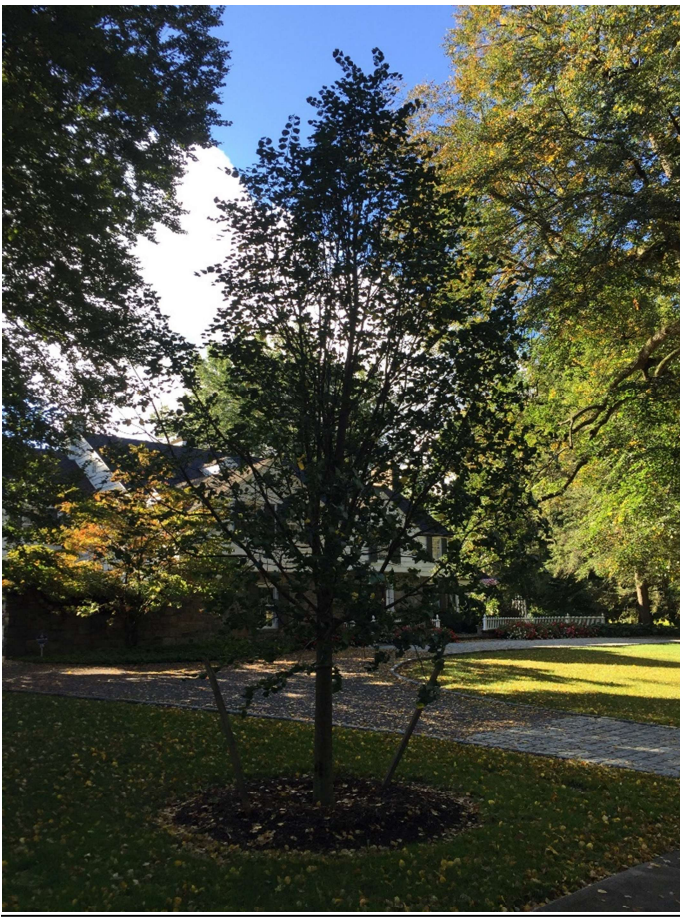
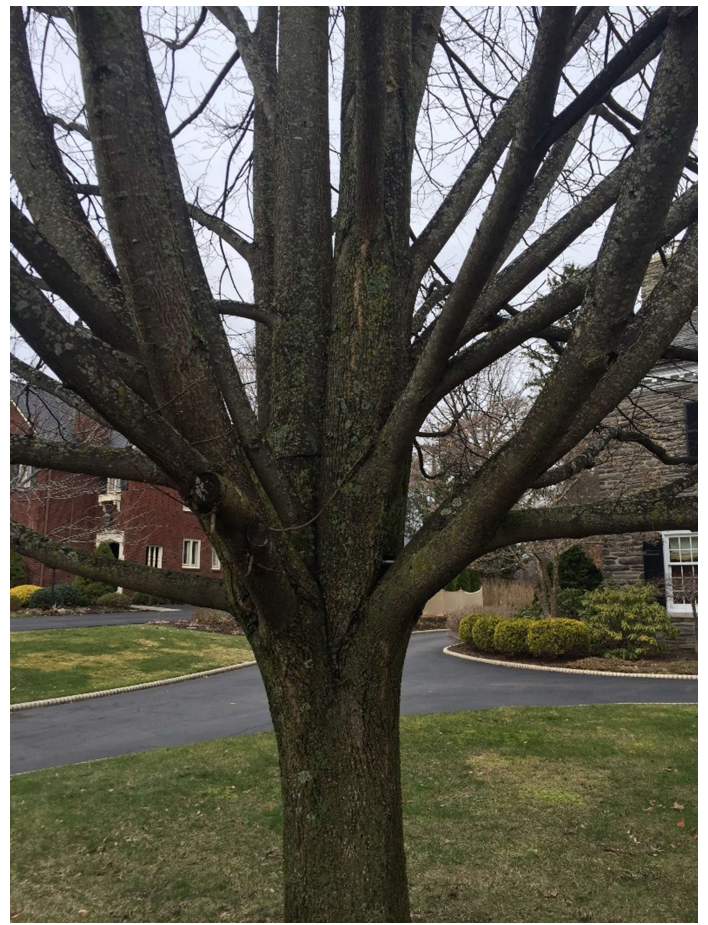
**Figure 12.** Two young lindens showing structural problems that should be corrected with pruning now before they become significant defects.

- **Structure prune young trees-** Many structural issues seen in mature trees could have been prevented with a handsaw if they were found when the tree was young (see Figure 12). A tree should be structurally pruned about 3 times between planting and medium age to establish a sound trunk and branch architecture; once at planting, once about 5 years after planting, and then again at around 15-20 years after planting (depending on species and location).
