# Update to the Houston Barnard Streetscape Plan

Prepared for The Garden Lovers Club

J. Galiley Arbor Consulting LLC

October 2020

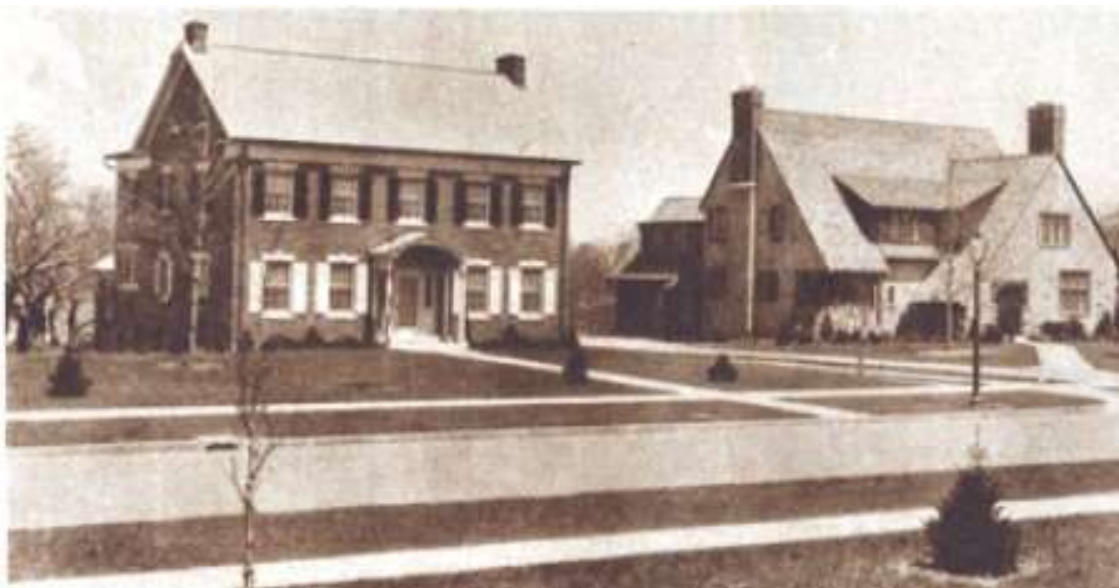
Figure 1. Newly planted linden trees and Douglas-fir trees in 1928 on Sandringham Road.

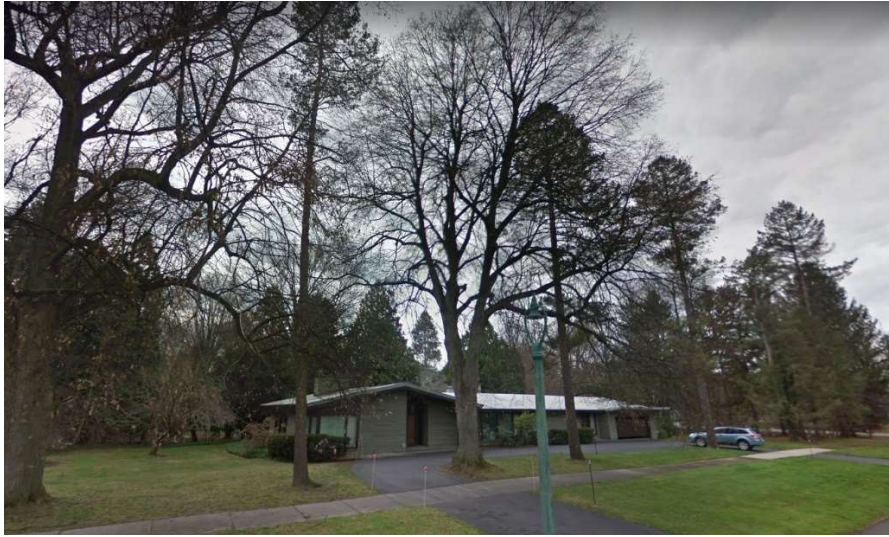
Figure 2. Mature linden and Douglas-fir trees in 2015 (from Google Street View) on Esplanade Drive near Clover Street. These trees are from the original streetscape of the neighborhood.
